SIXTH EDITION

2020 PV Module Reliability Scorecard

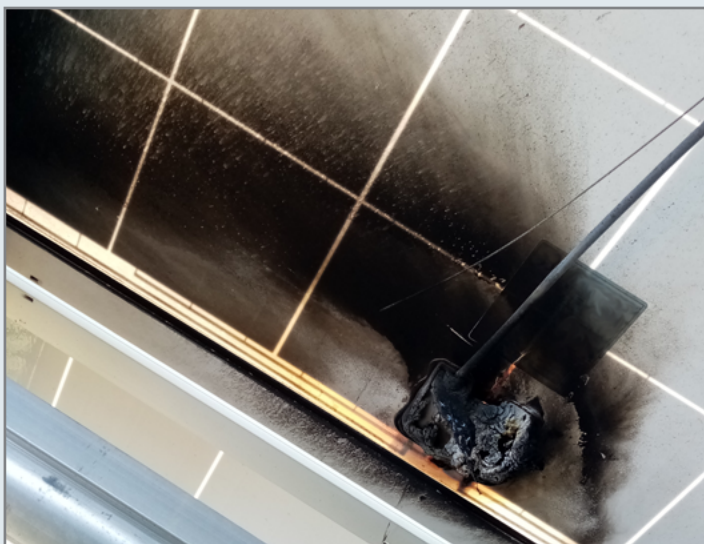
The image above shows a PV module at the project site with a junction box that melted due to electrical arcing.

A 50 MW PV plant in Africa built in 2013 began to exhibit serious failures from poor soldering and failed diodes after just five years of operation.

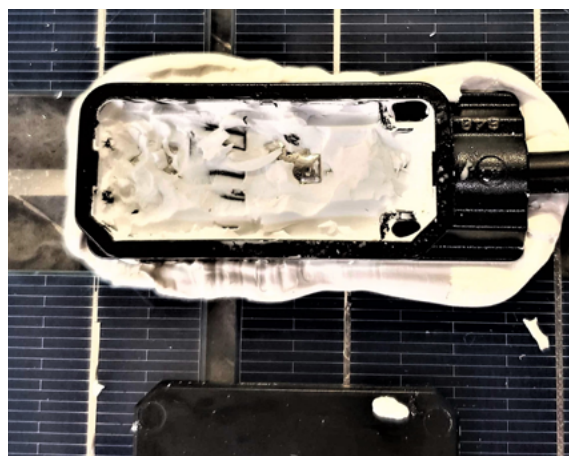
The junction box above became unsealed after damp heat testing.

Many of the recorded wet leakage failures were traced to poor sealing around the junction box via the junction box lid, adhesive or pottant. Correct placement of the lid and application of sealants are critical manufacturing processes, but they can be overlooked in the pursuit of production targets.

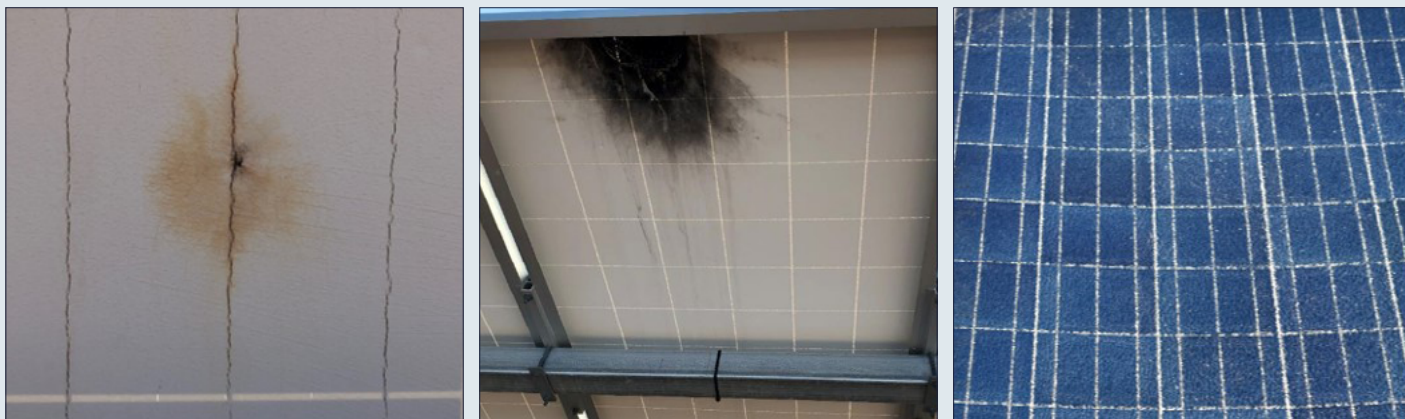
The pictures above are from a 17 MW project in the Southwest U.S. One hundred percent of the backsheets in this project are cracked. The severe scorching in the backsheet above was caused by electrical arcing at the backsheet cracks that intercept the frame. The thermal event shattered the front-side glass.

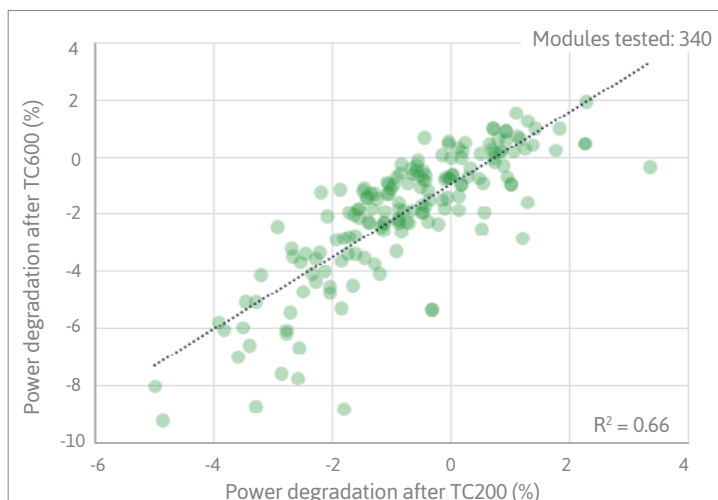
For the thermal cycling test, the correlation between 200 cycles and 600 cycles indicates no new mechanisms are being introduced by the 600 cycle test, yet stopping at 200 cycles might be premature (see figure below left). Reviewing the historical 600 cycle and 800 cycle correlation indicates that TC600 is a sufficient test duration. The damp heat correlation between 1000 hours and 2000 hours suggests 1000 hours is not an adequate substitute for 2000 hours (see figure below right), while the historical correlation between 2000 and 3000 hours indicates that less relevant failure mechanisms may be introduced. The data shows that 2000 hours is optimal.

Scatterplots showing correlations between various stages of the TC and DH tests
